Summary of Monitoring at Boat Landings and Water Inlets for Eurasian Water-milfoil (*Myriophyllum spicatum*) and Other AIS on Wood (Big Wood) Lake (WBIC: 2649800) Burnett County, WI

The Big Wood Lake Association and the Wisconsin Department of Natural Resources

Endangered Resource Services, LLC
Matthew S. Berg, Research Biologist
St. Croix Falls, Wisconsin
June-October, 2024

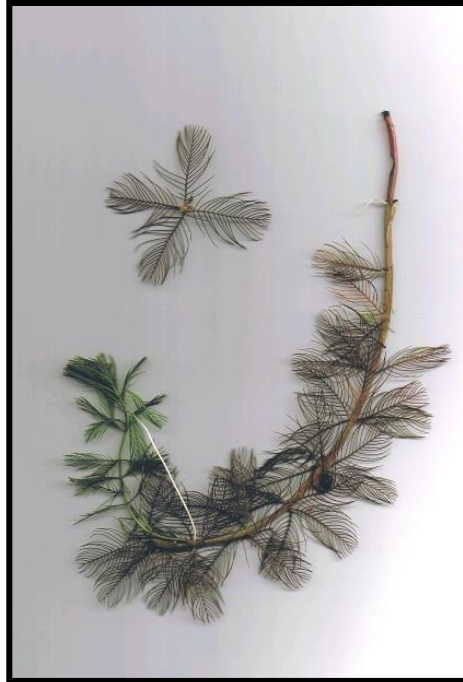
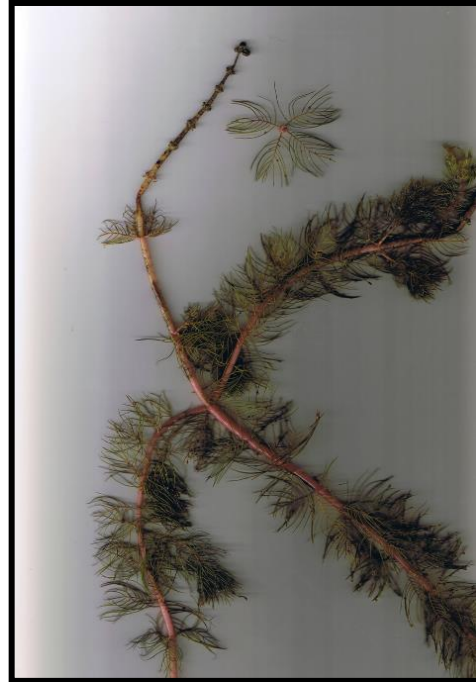
Eurasian water-milfoil

Northern water-milfoil

Figure 3: EWM and Northern Water-milfoil Identification (Berg 2007)

We completed landing transect and shoreline surveys on June 1st, July 3rd, July 30th, September 1st, and October 6th. **We did NOT find any evidence of Eurasian Water-milfoil anywhere in Big Wood Lake during any survey.** However, the lake again supported a moderately high population of the similar looking native species Northern water-milfoil (*Myriophyllum sibiricum*). NWM is widely distributed throughout Big Wood in all habitats, but it does best over sandy and organic muck. Despite its superficial resemblance to EWM, Northern water-milfoil can be told apart by its leaflets numbering <24 whereas EWM normally has >26 (Figure 3). EWM also tends to have a bright red growth tip on the top of the plant whereas NWM has a bright lime green growth tip. In the fall, NWM forms winter buds on the tips of shoots whereas EWM has none (Figure 4). These were evident on all NWM plants during the October survey.

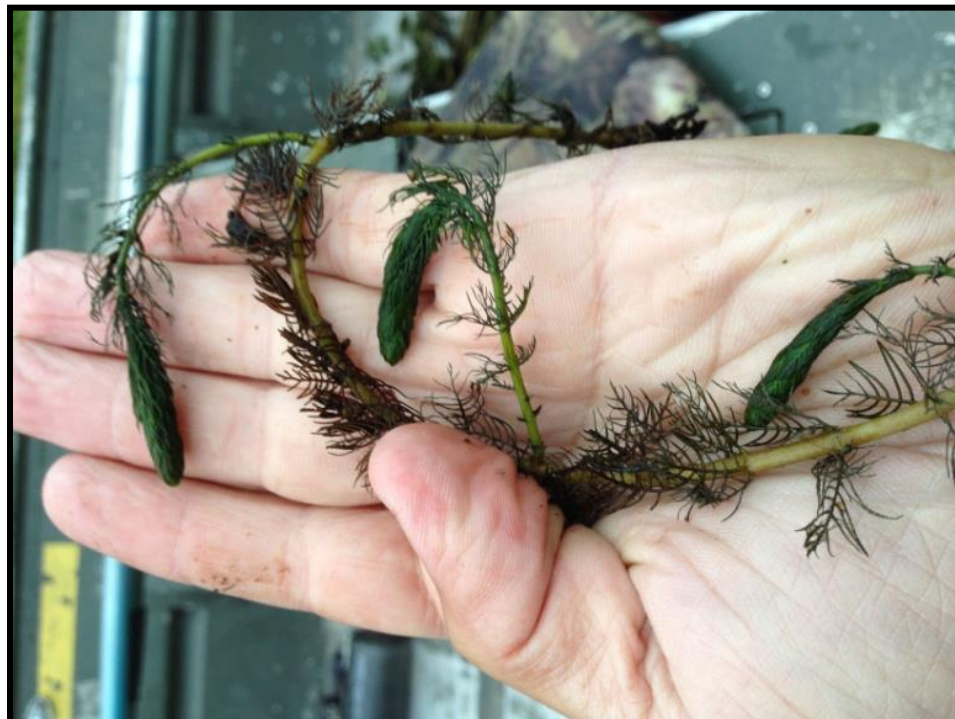
Figure 4: Overwintering Turions on Dying Northern Water-milfoil
(Berg 2016)

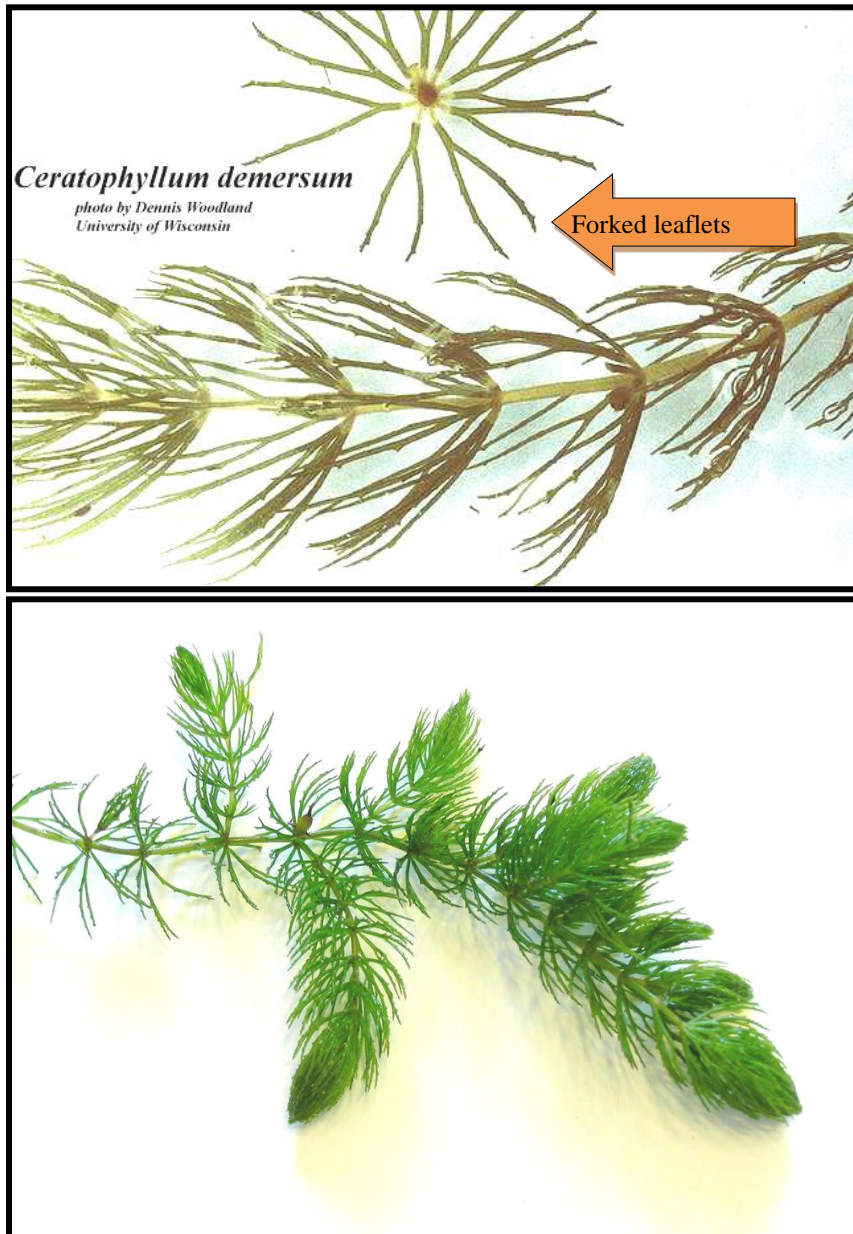
Figure 5: Coontail Identification

Coontail (*Ceratophyllum demersum*), another EWM lookalike that prompted several concerned residents to contact us this summer, is abundant on lake. It can be told from EWM by having leaflets that fork and have minute teeth (Figure 5)

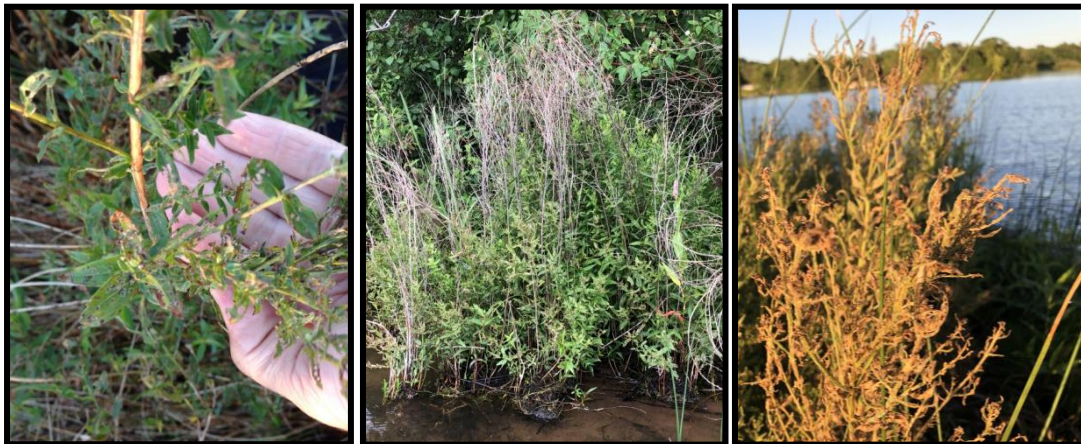
Figure 6: Plants on Central Island Showing Limited Herbivory on 10/6/16 (left), Moderate Herbivory on 7/25/20 (middle), and Extensive Herbivory on 8/1/21 (right)

Purple loosestrife (*Lythrum salicaria*) (PL), another exotic invasive plant, was again present in the wetlands adjacent to and along the immediate shoreline of the lake. This species prefers mucky soils and is increasing among the Cattails (*Typha* spp.) and Northern wild rice (*Zizania palustris*) near the Spirit Creek Inlet and just south of the Wood River Outlet. Unfortunately, these areas are difficult to impossible to safely reach for manual removal. Both of the central islands also have a number of plants including a monotypic stand on the south end of the north wooded island. In 2015, Galerucella beetles (an imported insect species that specializes in eating PL) were raised and released by Grantsburg High School students at this location. Although beetles were visible on plants throughout the summers of 2016 and 2017, until 2018, they showed little effect on the island's PL population. However, since then, the beetles have caused moderate to extensive herbivory, and we found a single flower that made it to bloom on the islands in 2021 and none in 2022, 2023, or 2024 (Figure 6). Although the beetles won't kill the roots, this prevents the majority of plants from flowering and spreading. Another positive development was the natural dispersal of these micro-herbivores as we again located at least some live beetles on all loosestrife plants growing on the islands as well as on plants near the Spirit Creek Inlet. **This suggests no more beetles need to be released on the lake at this time.**

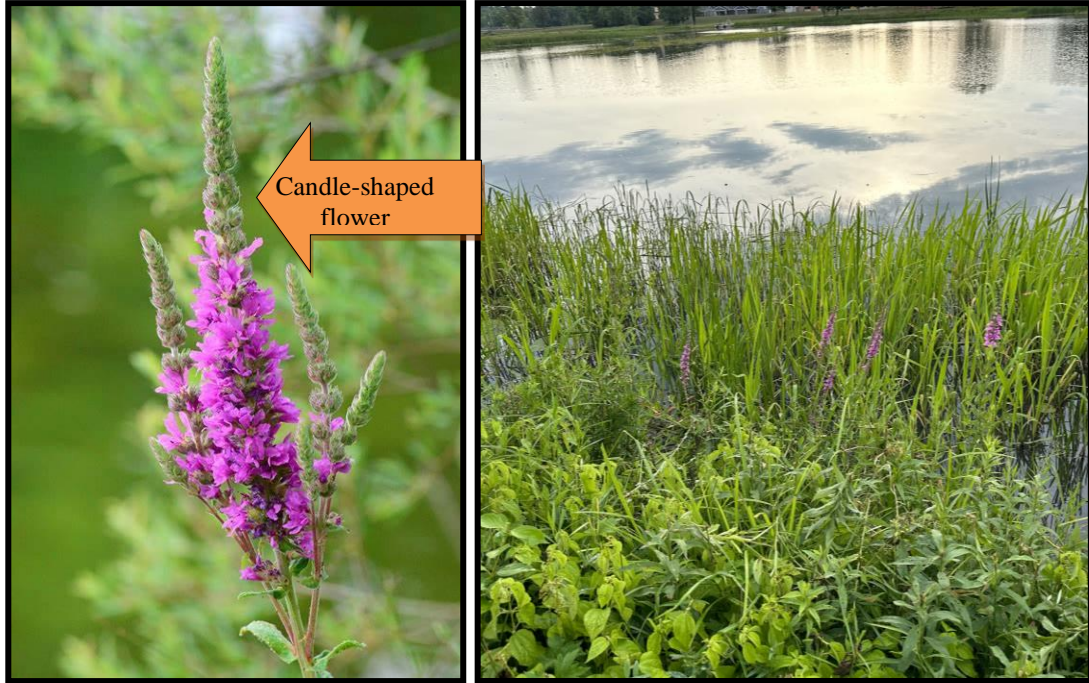
Figure 7: Purple Loosestrife Identification/Plants on a Nearby Lake

Purple loosestrife was formerly widespread along the western shoreline of the lake south of the Wood River Outlet. In 2018, students from GHS performed manual removal of all plants along this shoreline that were safely accessible/not in a wetland (see 2018 annual report). This removal has proven to be very effective as we did not find any surviving plants along these residential shorelines during any of our 2019-2024 surveys. Despite this, residents are encouraged to continue to look for and remove any PL plants they find on their property in August/September when the bright fuchsia candle-shaped flower spikes are easily seen and before they can set seed (Figure 7). Plants should be dug out with a shovel, bagged, and disposed of well away from any wetland. Also, because the plants have an extensive root system, care should be taken to remove the entire plant as even small root fragments can survive and produce new plants the following year.

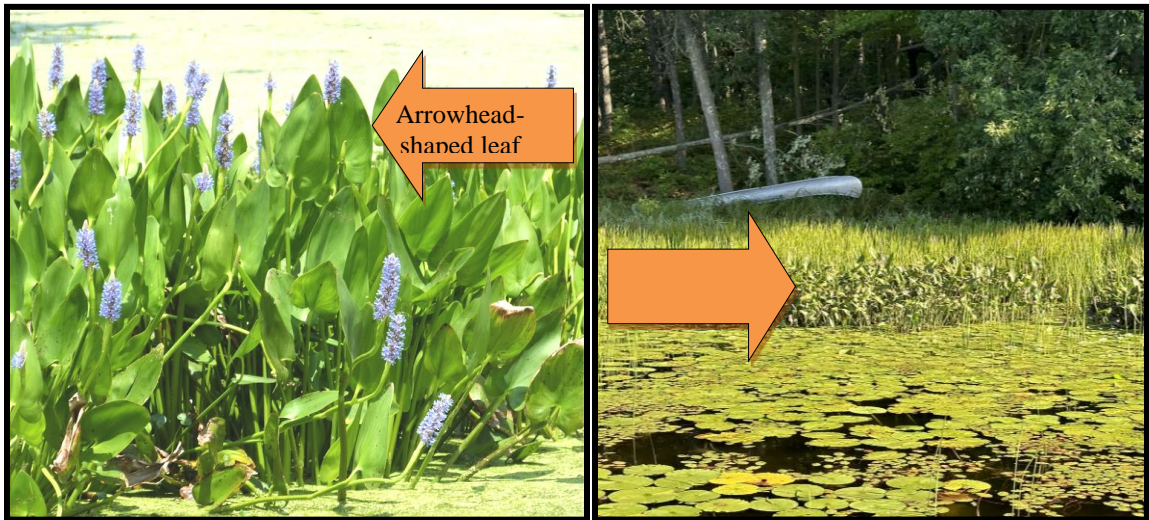
Figure 8: Pickerelweed Identification/Typical Patch in the Shallows

Concern about Purple loosestrife also prompted several calls from lake residents in 2024. Each plant of concern turned out to be a somewhat similar looking native species – Pickerelweed (*Pontederia cordata*) (Figure 8) – which is scattered around the Big Wood shoreline.
